# Technical Service Bulletin

## 91 MIB2 High: Bang & Olufsen subwoofer settings missing from MMI tone settings menu

91 19 32 2053533/2 February 1, 2019. Supersedes Technical Service Bulletin Group 91 number 19-27 dated January 14, 2019 for reasons listed below.

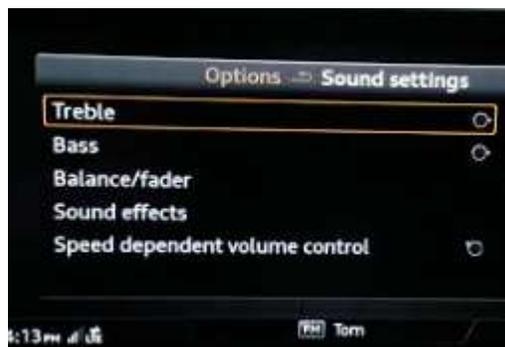
- The subwoofer adjustment is missing in the MMI for vehicles equipped with Bang & Olufsen (PR Code 9VS) and the customer vehicle has MMI Navigation (PR Code I8H & I8L) (Figure 1).

Figure 1. Sound settings is missing the subwoofer option.

The MIB2 software needs to be updated.

Update the MIB2 High infotainment system using either Method 1 or Method 2 according to TSB 2047576: *91 MIB2 High Software Update Instructions (PR Code 7UG)* and use SVM code indicated below:
